TECH TIP

OIL LEAKAGE 216

TROUBLESHOOTING OIL LEAKS

The Filter Often Gets the Blame

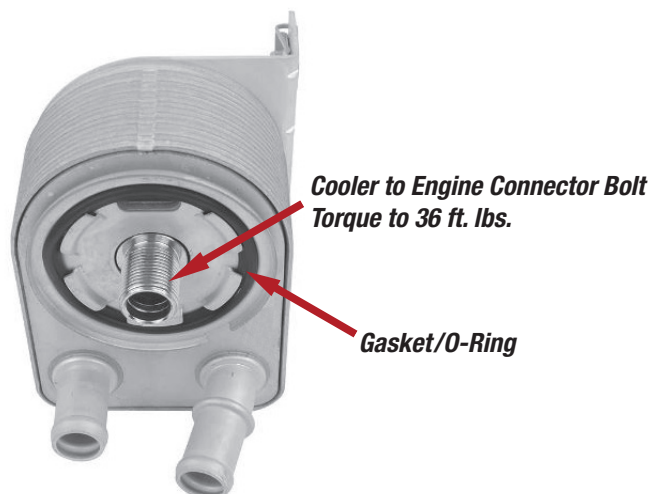
Fig. 1

The engine side of the oil cooler is sealed to the engine with a gasket/O-ring secured by a connector bolt. The opposite end of this bolt also serves as the oil filter attachment point. The bolt should be torqued to 36 ft. lbs. (see Fig.1). It is possible for the connector bolt to loosen in the process of multiple oil filter changes, resulting in leakage. Eventual gasket

compression can also occur, requiring a replacement gasket between the cooler and engine.

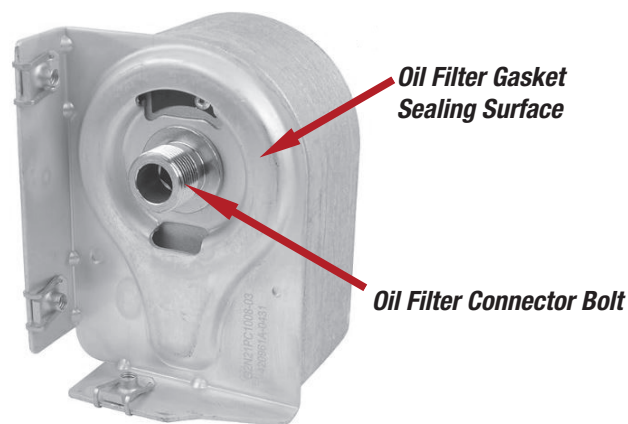
Fig. 2

The oil filter side of the oil cooler (see Fig. 2) should be inspected for damage or deformation that could prevent the oil filter gasket from sealing properly to the cooler. The cooler is a stamped piece of metal and not a machined surface like the engine block. Overtightening the connector bolt can result in damage or distortion to the cooler. A bolt that is not properly torqued can loosen when performing oil filter changes, especially if the oil filter was previously overtightened.

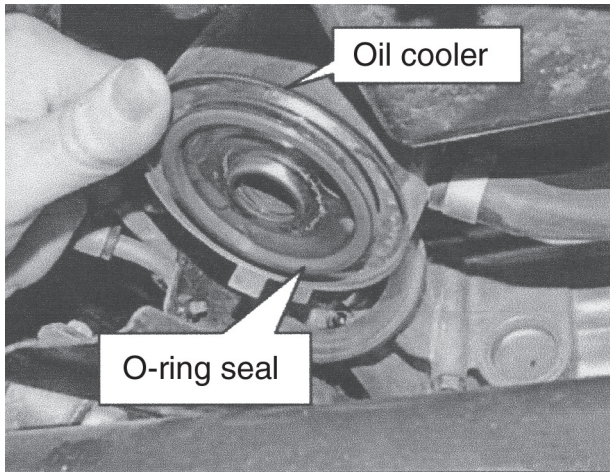
Fig. 3

Oil cooler leakage has plagued Nissan applications equipped with VQ30 (3.0L) and VQ35 (3.5L) engines since the year 2000. The same oil cooler arrangement is included with current production vehicles. These applications call for the M4612 series filter, which has been mistakenly blamed for the oil leakage. The leakage occurs due to a poor seal between the oil cooler O-ring and the engine. Nissan has a revised O-ring for the oil cooler, which is not a typical O-ring, requiring a trip to the dealer (see Fig. 3).

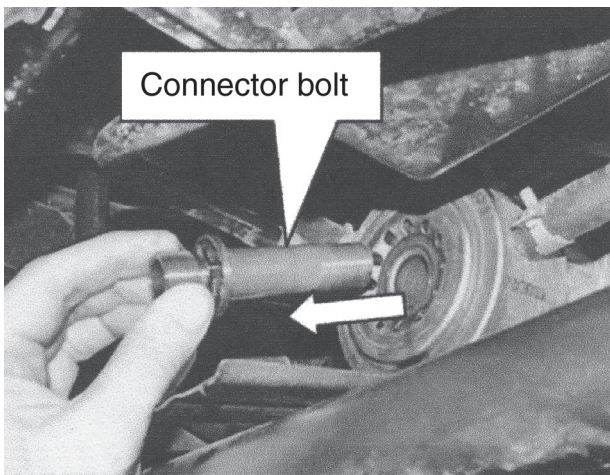
Fig. 4

Nissan recalled certain production vehicles including: 2011-2012 Nissan Frontier, Xterra, Pathfinder and Nissan NV vehicles. Some of the connector bolts that secure the oil cooler to the engine were manufactured below specification strength. The bolts may break at the oil filter attachment point resulting in leakage (see Fig. 4). The torque spec for the connector bolt is 36 ft. lbs.

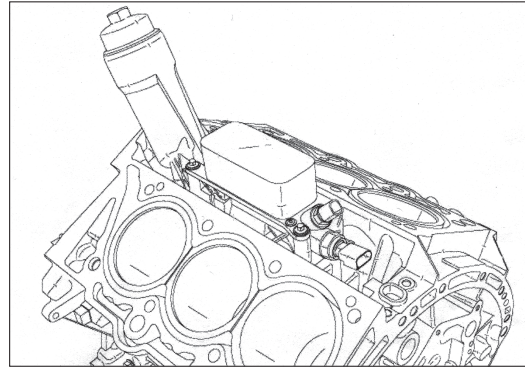
Fig. 5

Filter housing and cooler leakage has plagued Chrysler's 3.6L Pentastar engine. The plastic housing and cooler assembly is positioned beneath the intake manifold between the cylinders (see Fig. 5). This area may accumulate a quart of oil before displaying any sign of a leakage. This may prevent the technician from observing any leakage following the lube service. When changing the oil filter, the cap should not be overtightened. The cap is stamped with a torque spec of 25 Nm (18 ft. lbs.). Overtightening can damage the cooler housing in the form of cracks or disturbing the housing O-rings, promoting oil or coolant leakage.

To check for oil pooling in the engine valley, fabricate a dip stick (preferably of wood) and insert it next to the oil filter housing and allow it to bottom out in the engine valley.

If oil is pooling in this area, the oil filter/cooler housing will most likely require replacement. A small amount of oil (wetness) on the tip of the fabricated dip stick may be the result of spillage when changing the oil filter and should be no cause of concern.

The presence of oil pooling in this area calls for an immediate discussion with the vehicle owner prior to performing a lube service. If the customer is not receptive to having the housing replaced, make certain you document your recommendation on the repair order and retain a copy. We have read reports of vehicles encountering fires due to oil leakage from the oil filter housing. For additional information and illustrations refer to Tech Tip 180 Chrysler's 3.6L Pentastar Engine.
