Oil Cooler Leakage The Oil Filter Is Often Blamed

By Larry Hammer
Technical Services

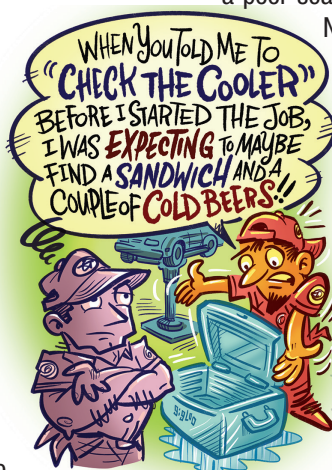
The plastic filter housing and cooler assembly on the 3.6L Pentastar engine has a history of oil leakage. The housing is positioned beneath the intake manifold (engine valley) and has a history of leakage. The leakage is not often immediately visible following an oil change as this area may accumulate a quart of oil before displaying any sign of leakage. Damage to the cooler housing in the form of cracks or disturbing the O-rings often occurs due to overtightening the oil filter cap during a lube service, resulting in oil or coolant leakage. The torque spec on the cap is 25 Nm (18 ft. lbs.). To check for oil pooling in the engine valley, fabricate a dipstick (preferably of wood) and insert it next to the oil filter housing and allow it to bottom out at the base of the engine valley. A small amount of wetness on the tip of the dipstick may be the result of spillage when changing the oil filter and should be no cause for concern. Pooling in this area should receive immediate attention, as the potential for a fire exists.
